Davidson School – Visioning Session

May 07, 2019

CREECH & ASSOCIATES

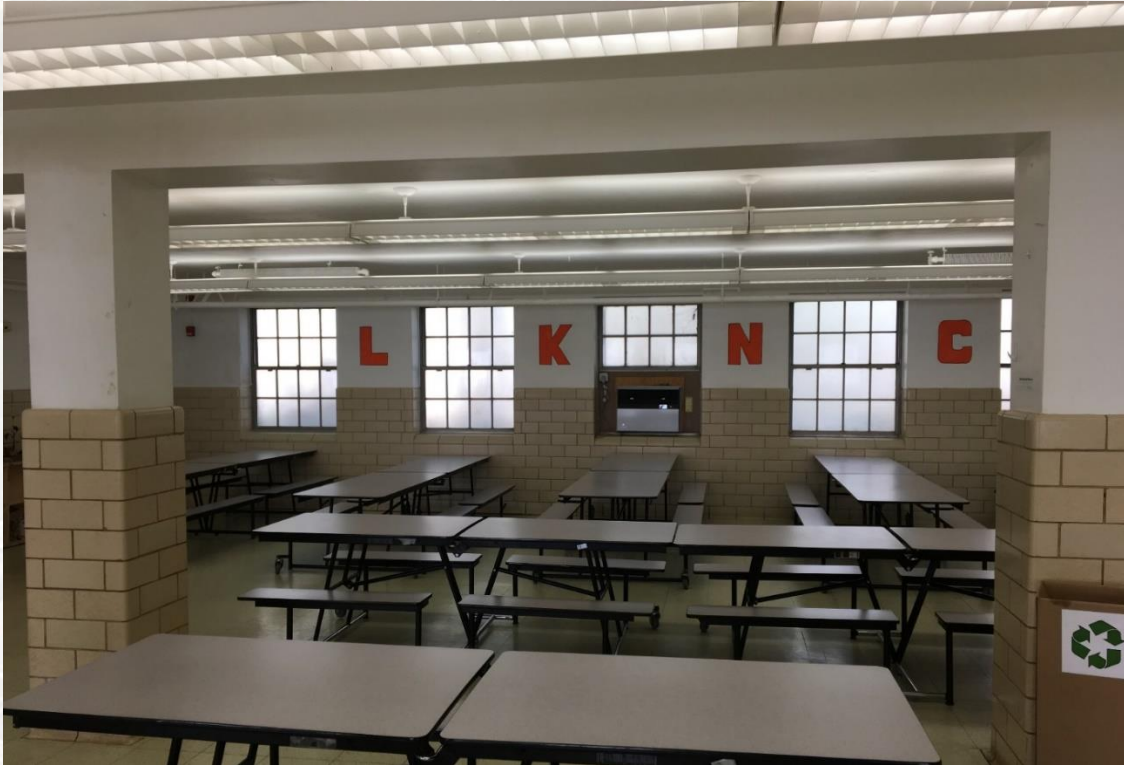
Lower Level Community Space

- *Subway tile wainscot to remain*
- *New lighting fixtures, flooring, and paint*
- *Remove frosting from windows for daylight*
- *Multiple smaller meetings simultaneously*
- *Adequate acoustical separation*
- *Flexible furniture*

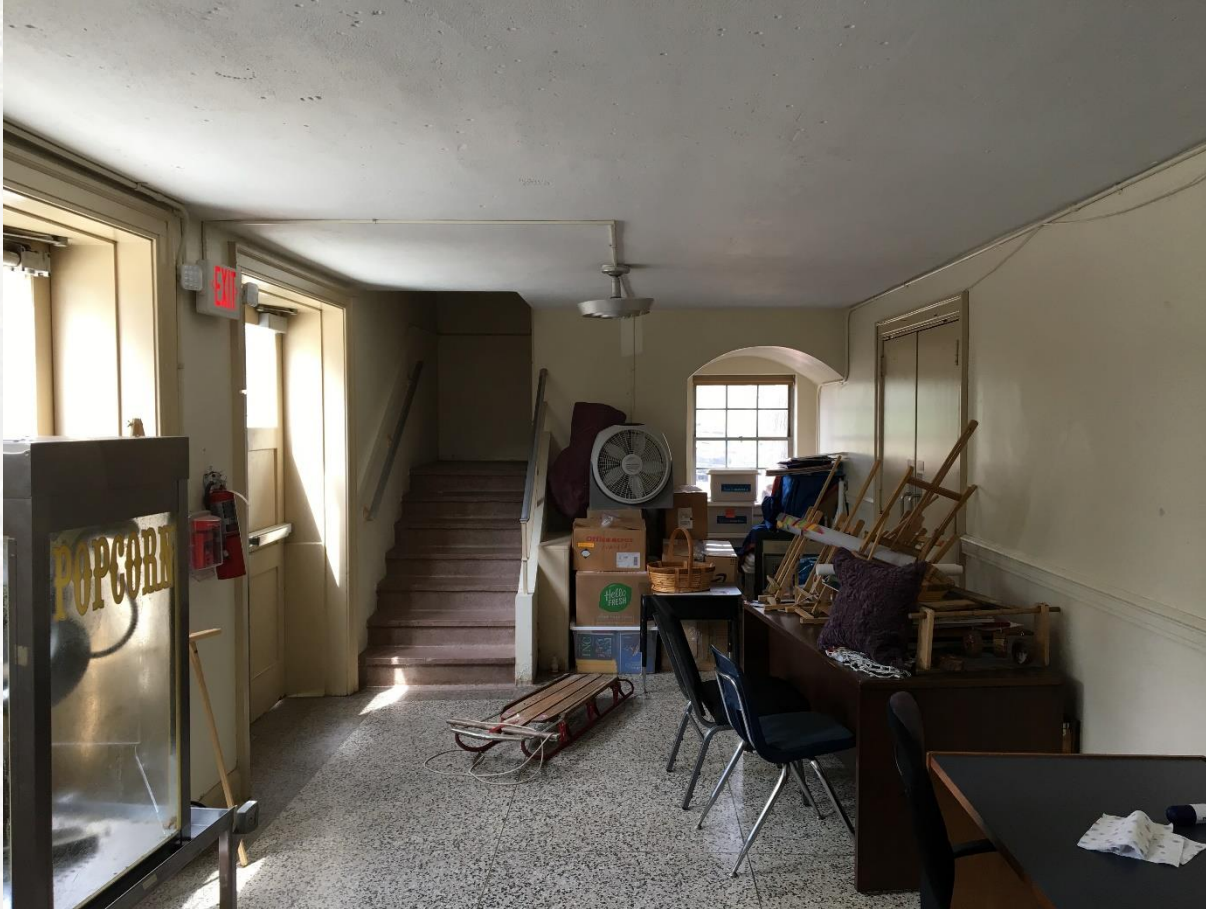
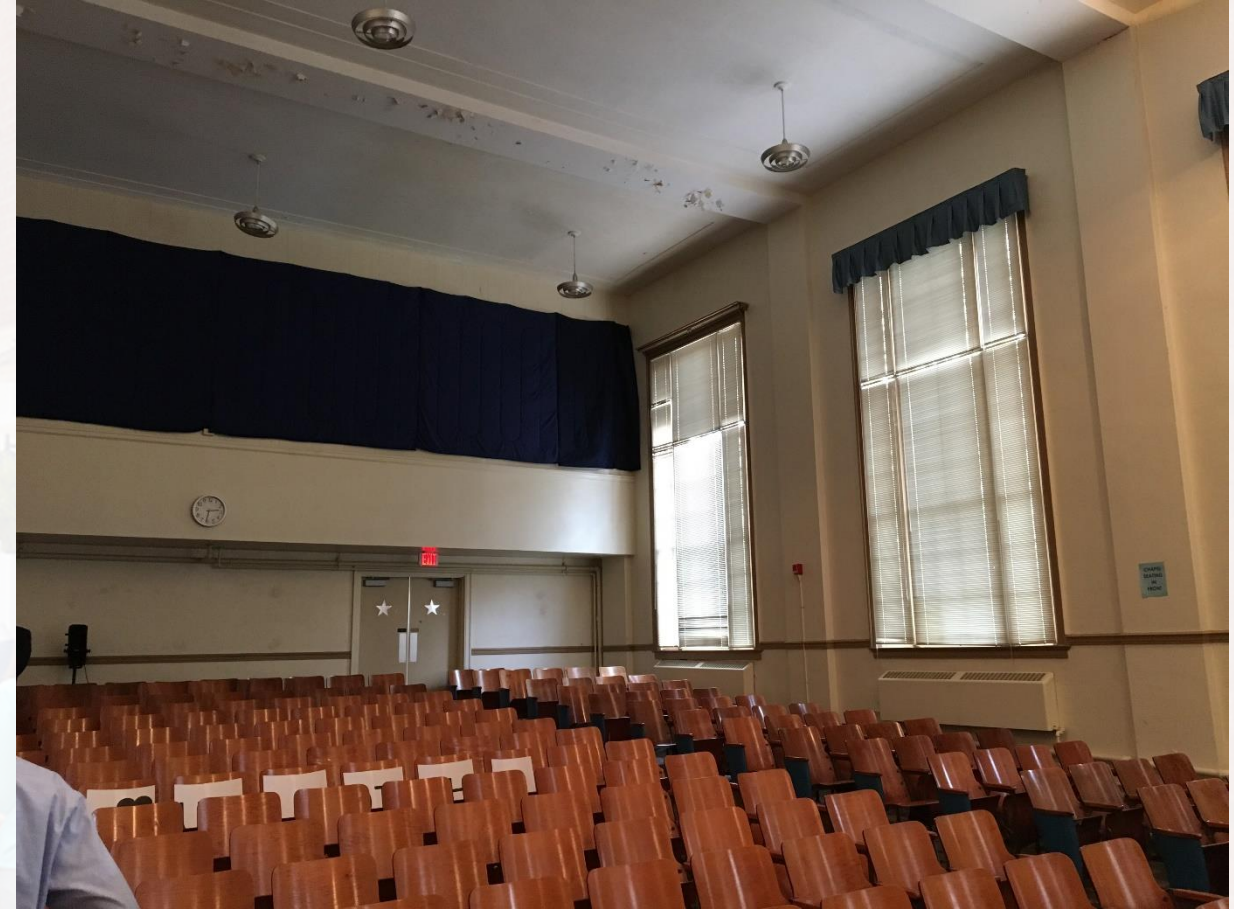
Auditorium: Existing Conditions

Single story lobby with unused balcony

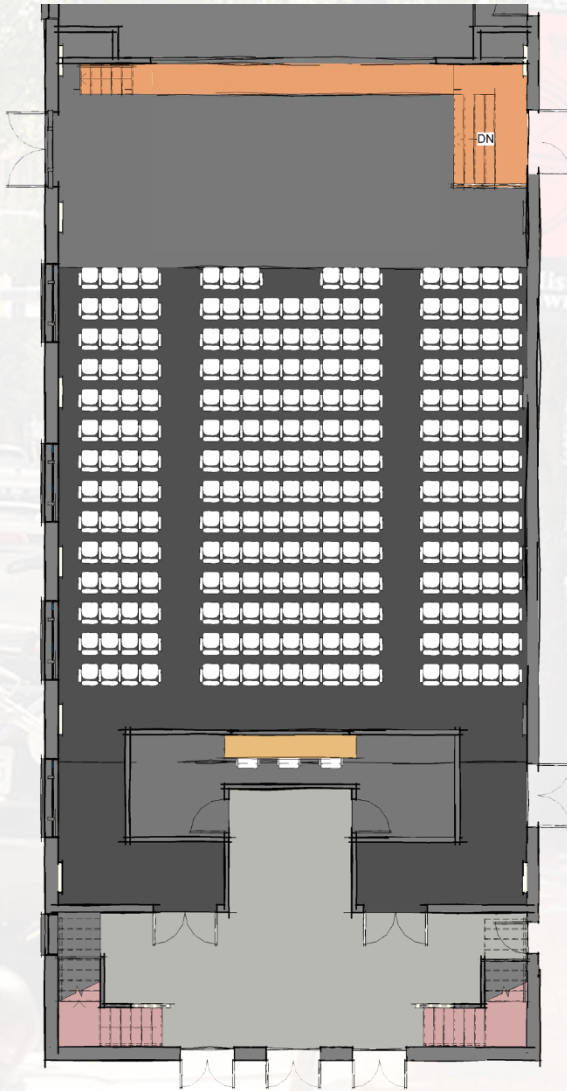
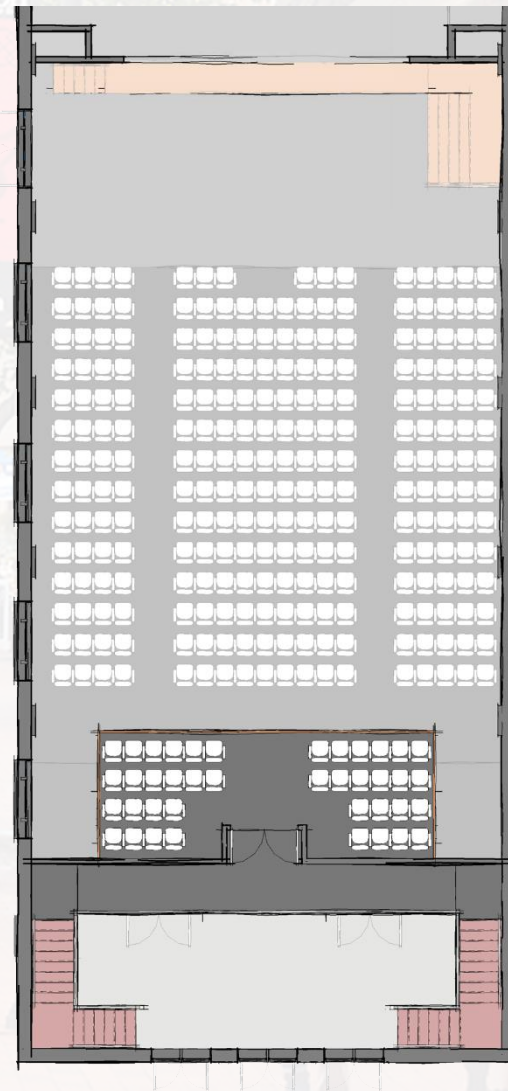
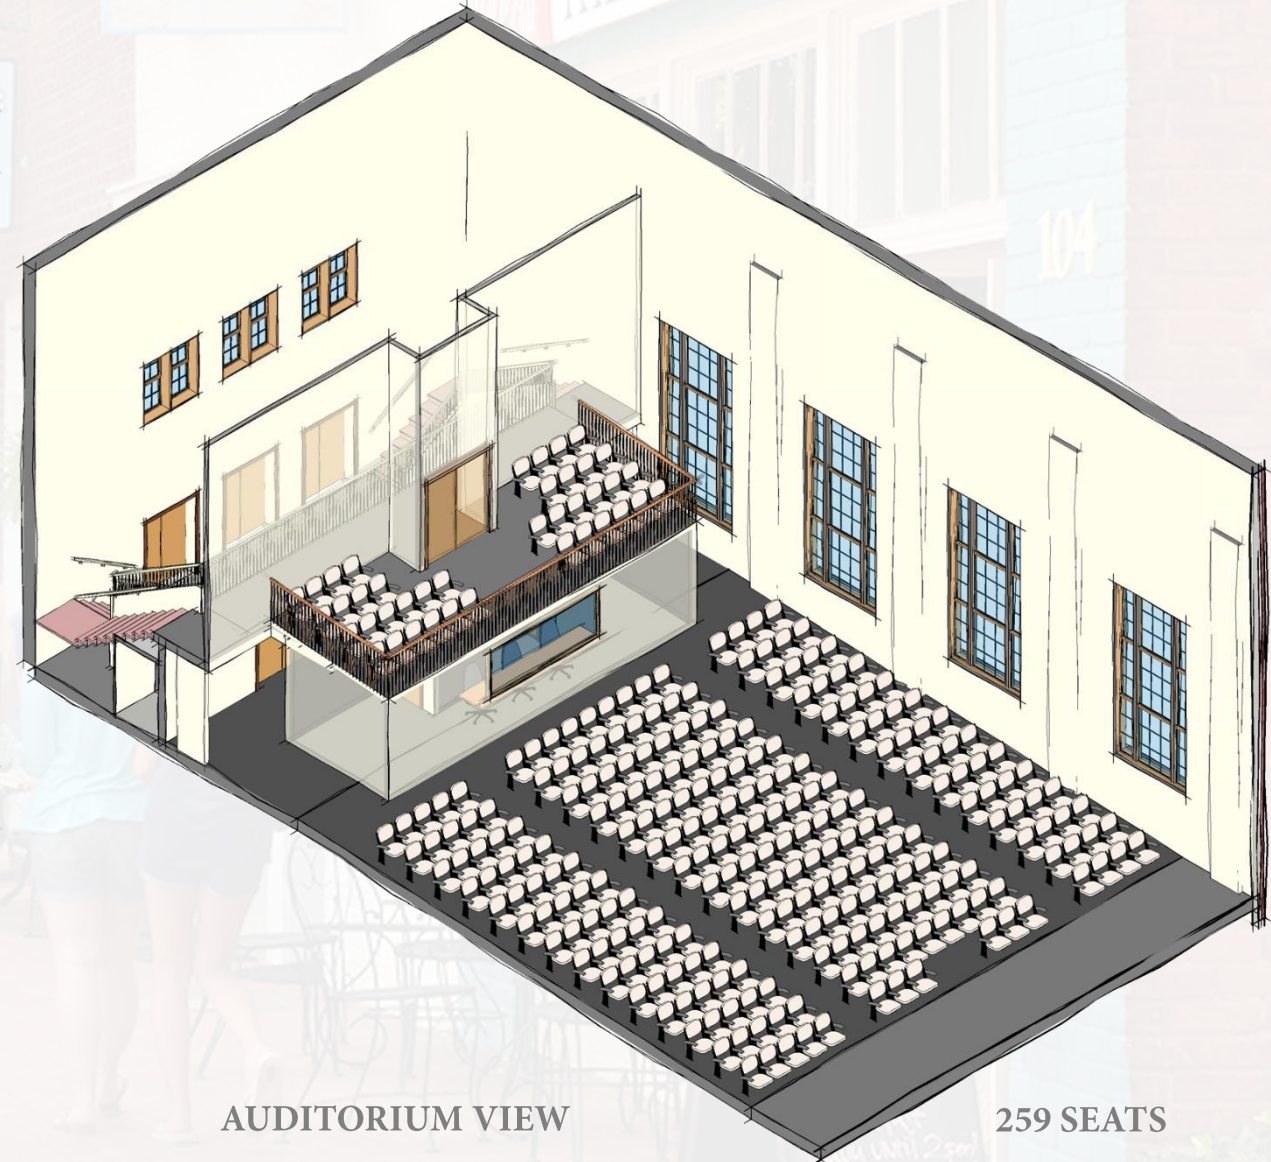
Auditorium: Option A

AUDITORIUM VIEW

259 SEATS

Balcony seating for 40

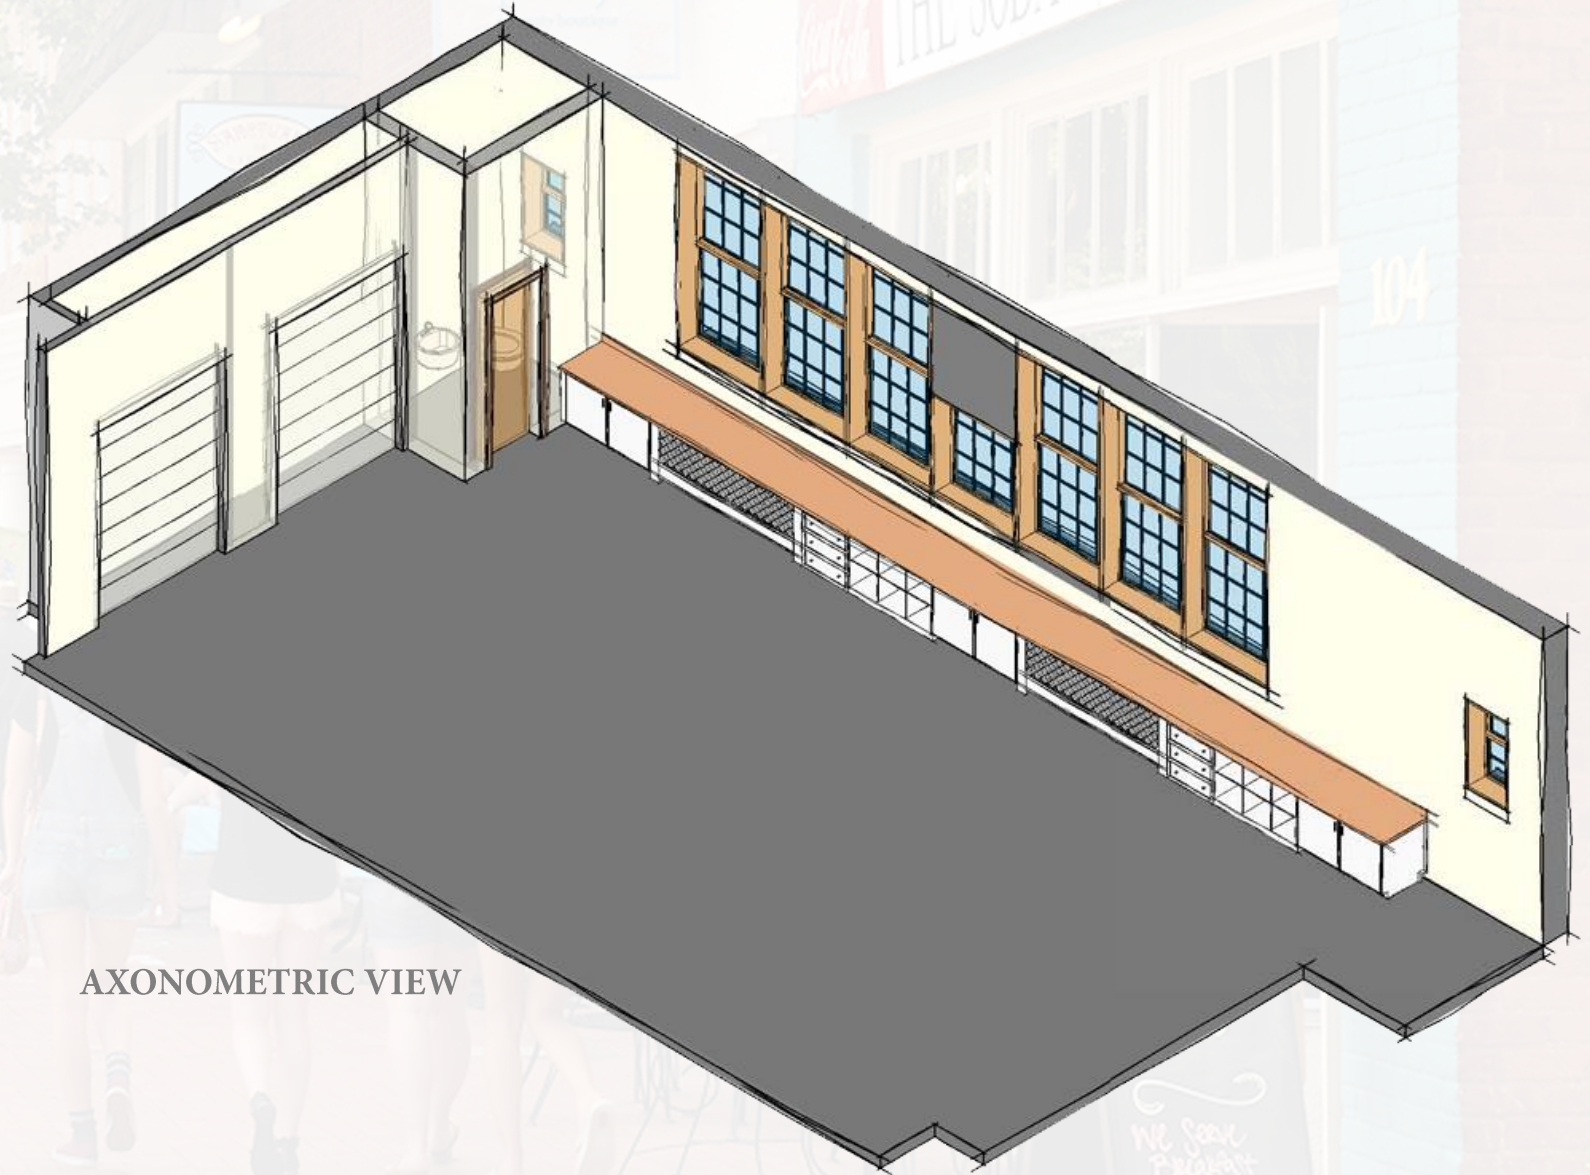
AXONOMETRIC VIEW

Open spaces with no interior partitions

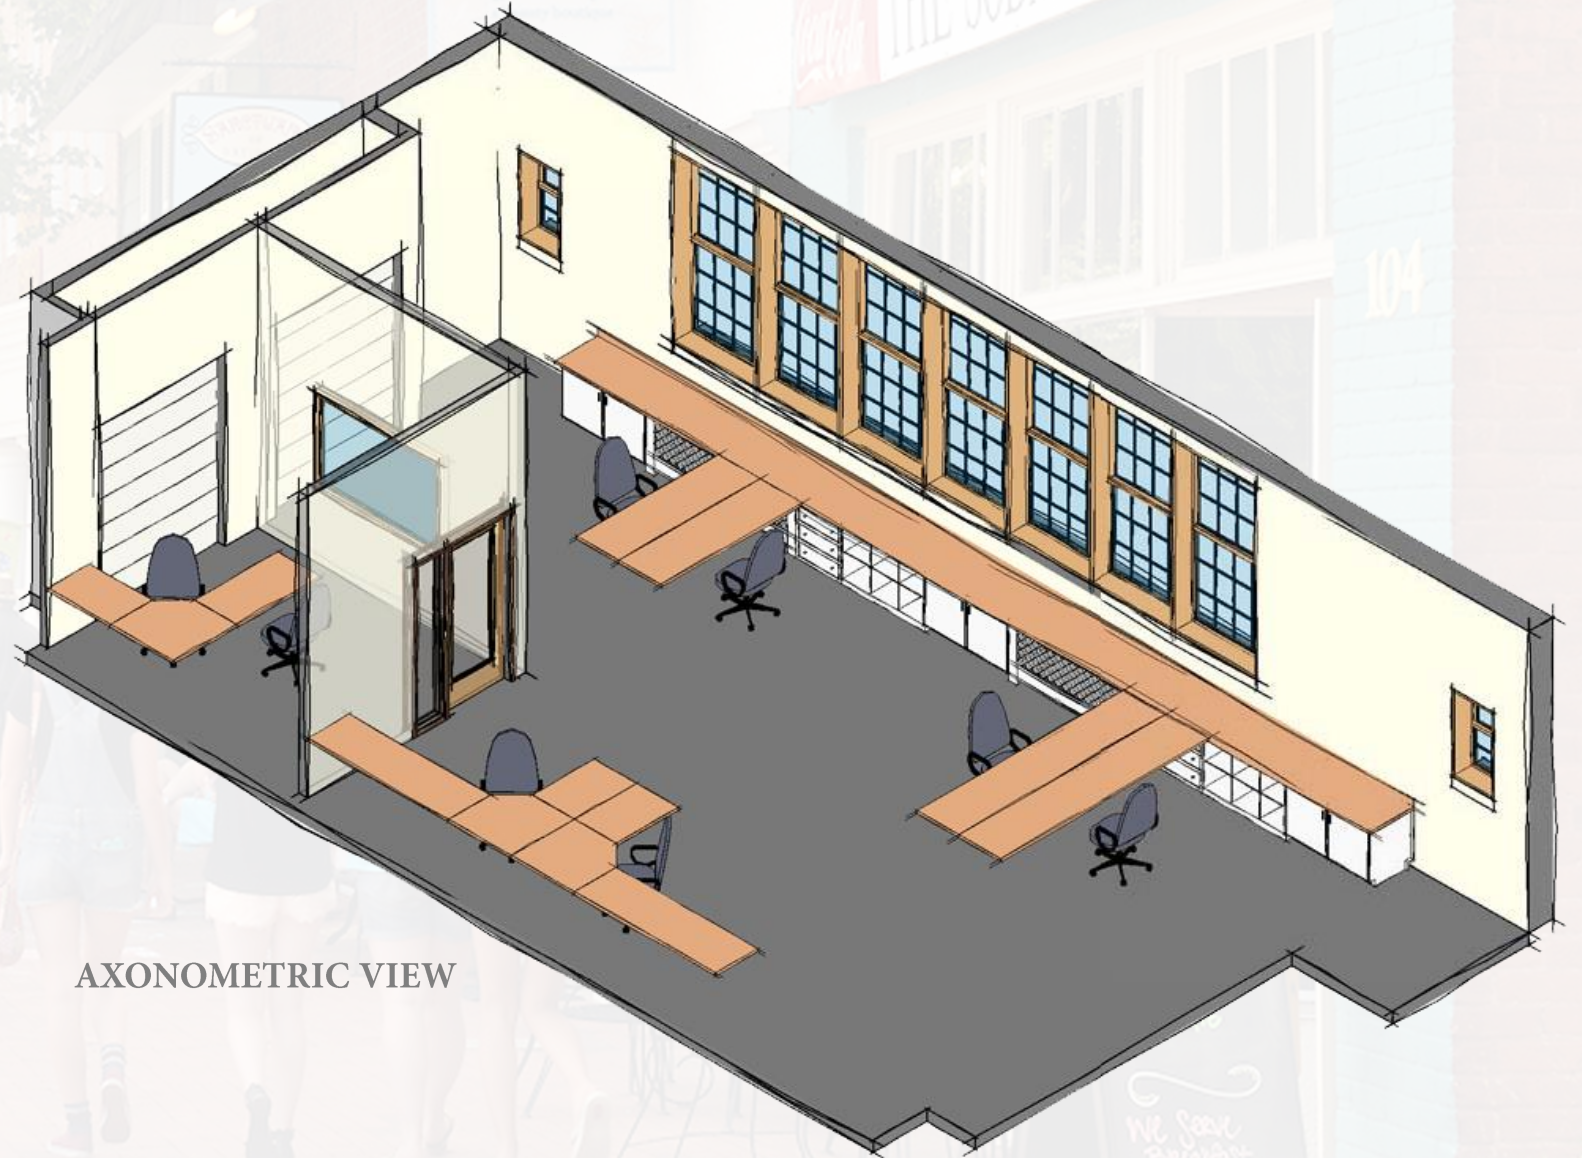
AXONOMETRIC VIEW

Open workstations with limited interior partitions
