# NORTHEAST AND NORTHWEST ELEVATIONS COMMUNITY CENTER

## SOUTH AND EAST ELEVATIONS HEALTH CARE ADDITION

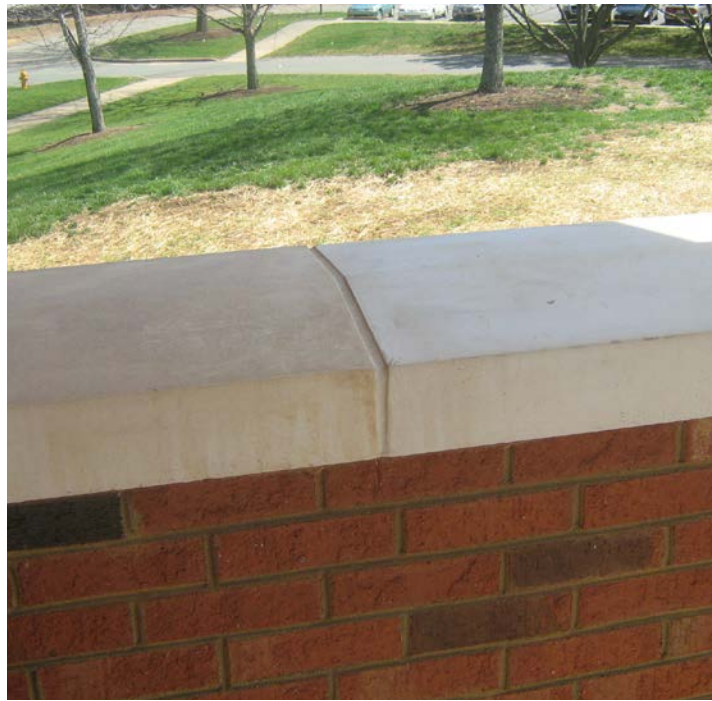
PRECAST CAP

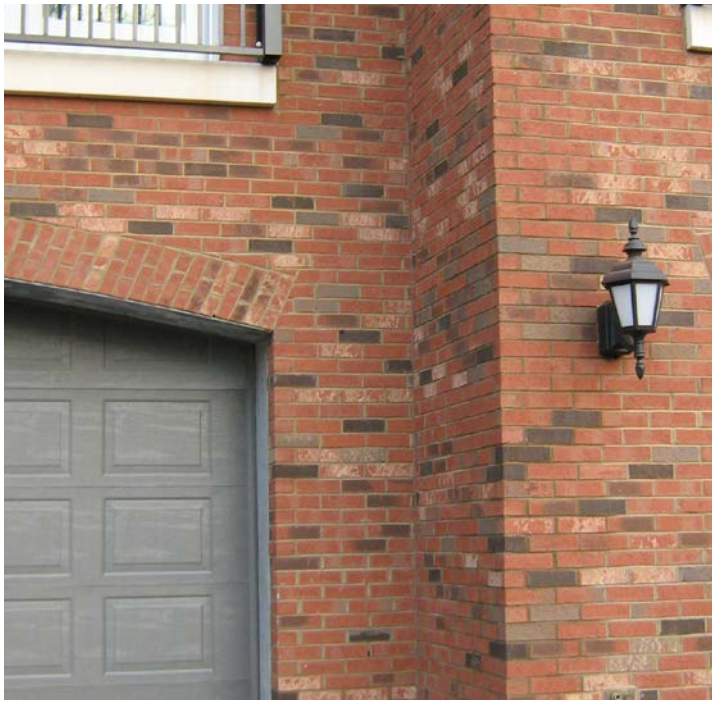
SOILDER COURSE AND BRICK DETAILS

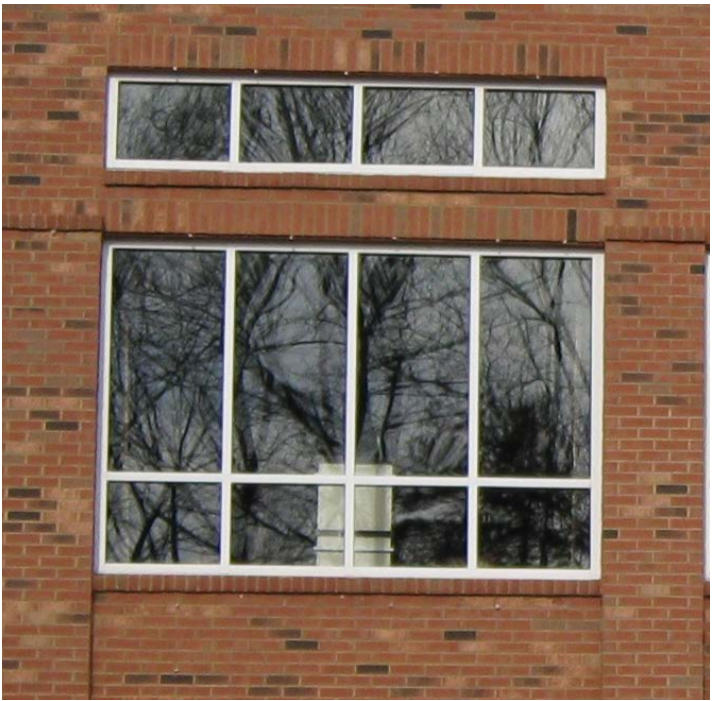
SOILDER COURSE AND BRICK LEDGER DETAILS

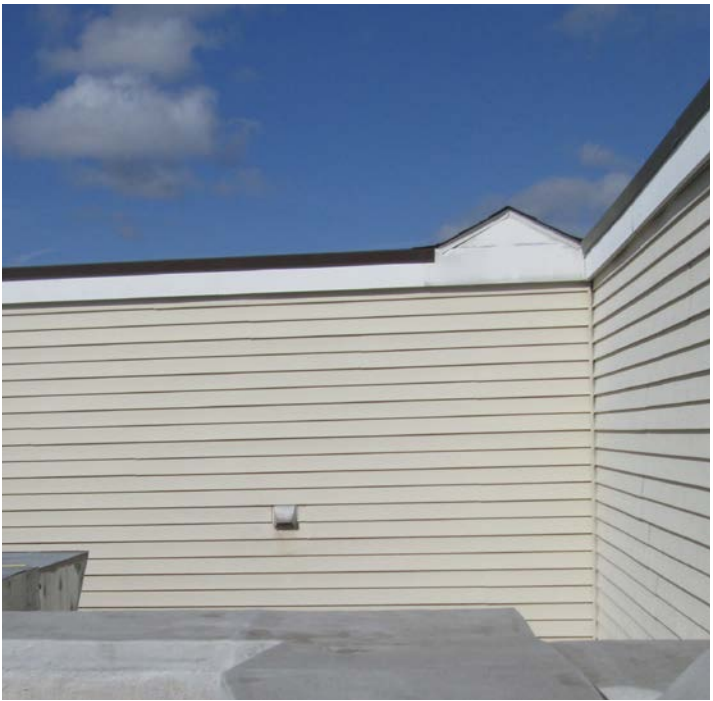
LAP SIDING

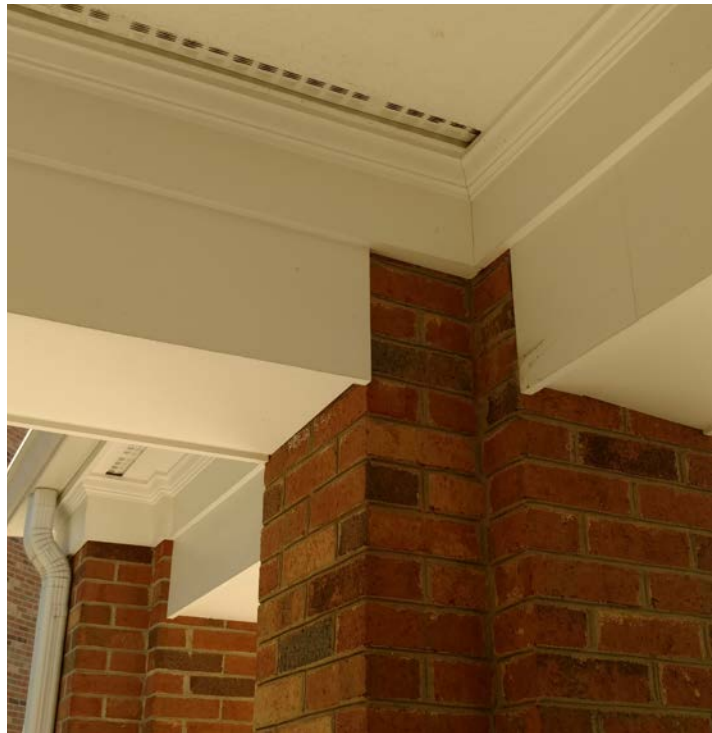
BRICK COLUMN AND SOFFIT AT PORTE COCHERE

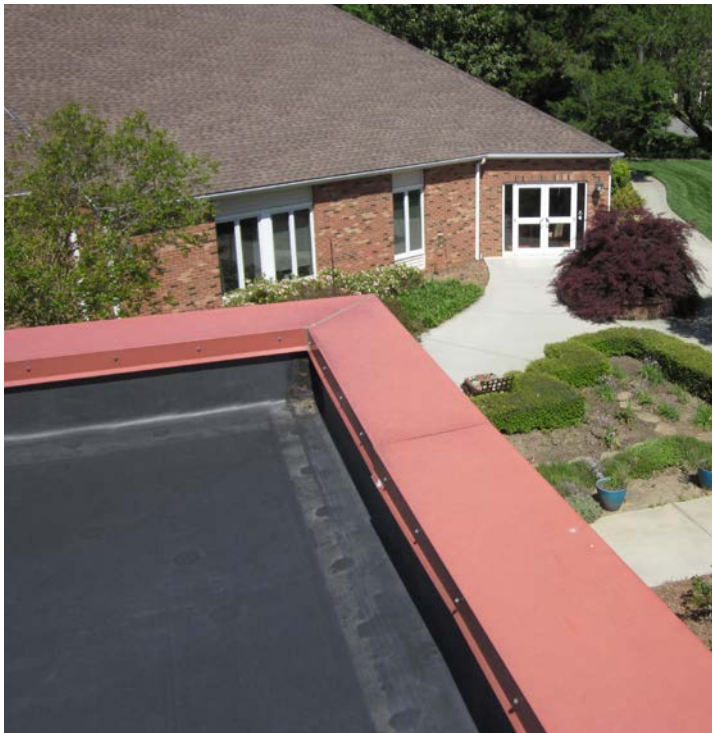
METAL COPING

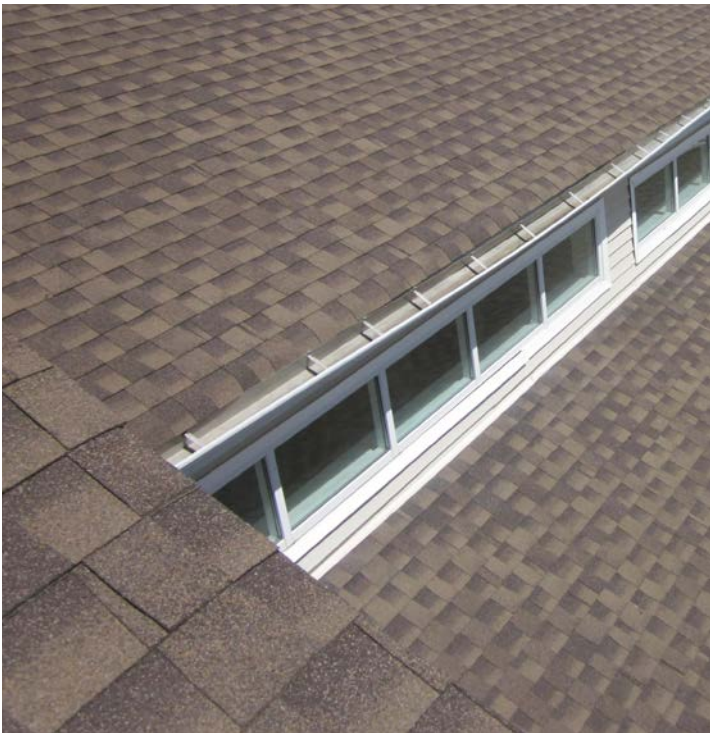
ARCHITECTURAL SHINGLES

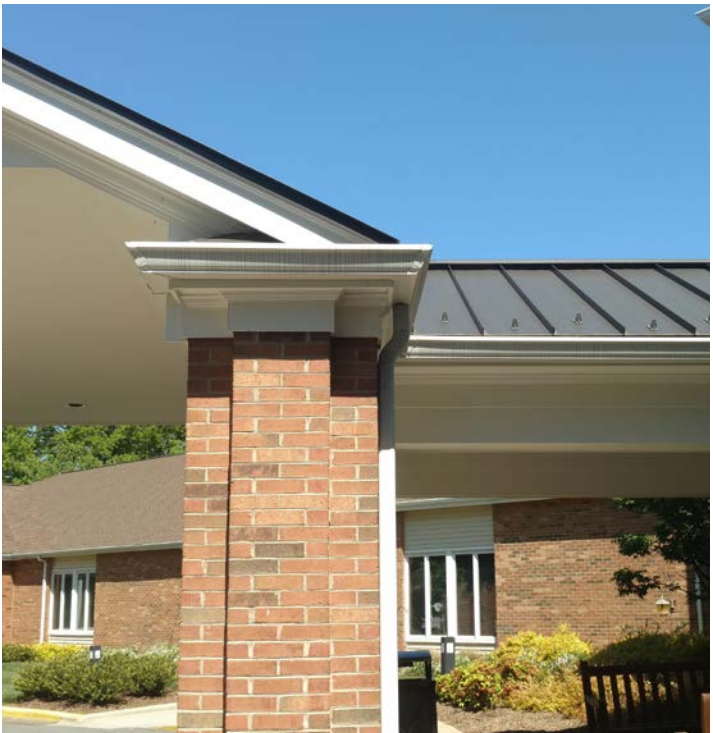
STANDING SEAM METAL ROOF AND BRICK COLUMN

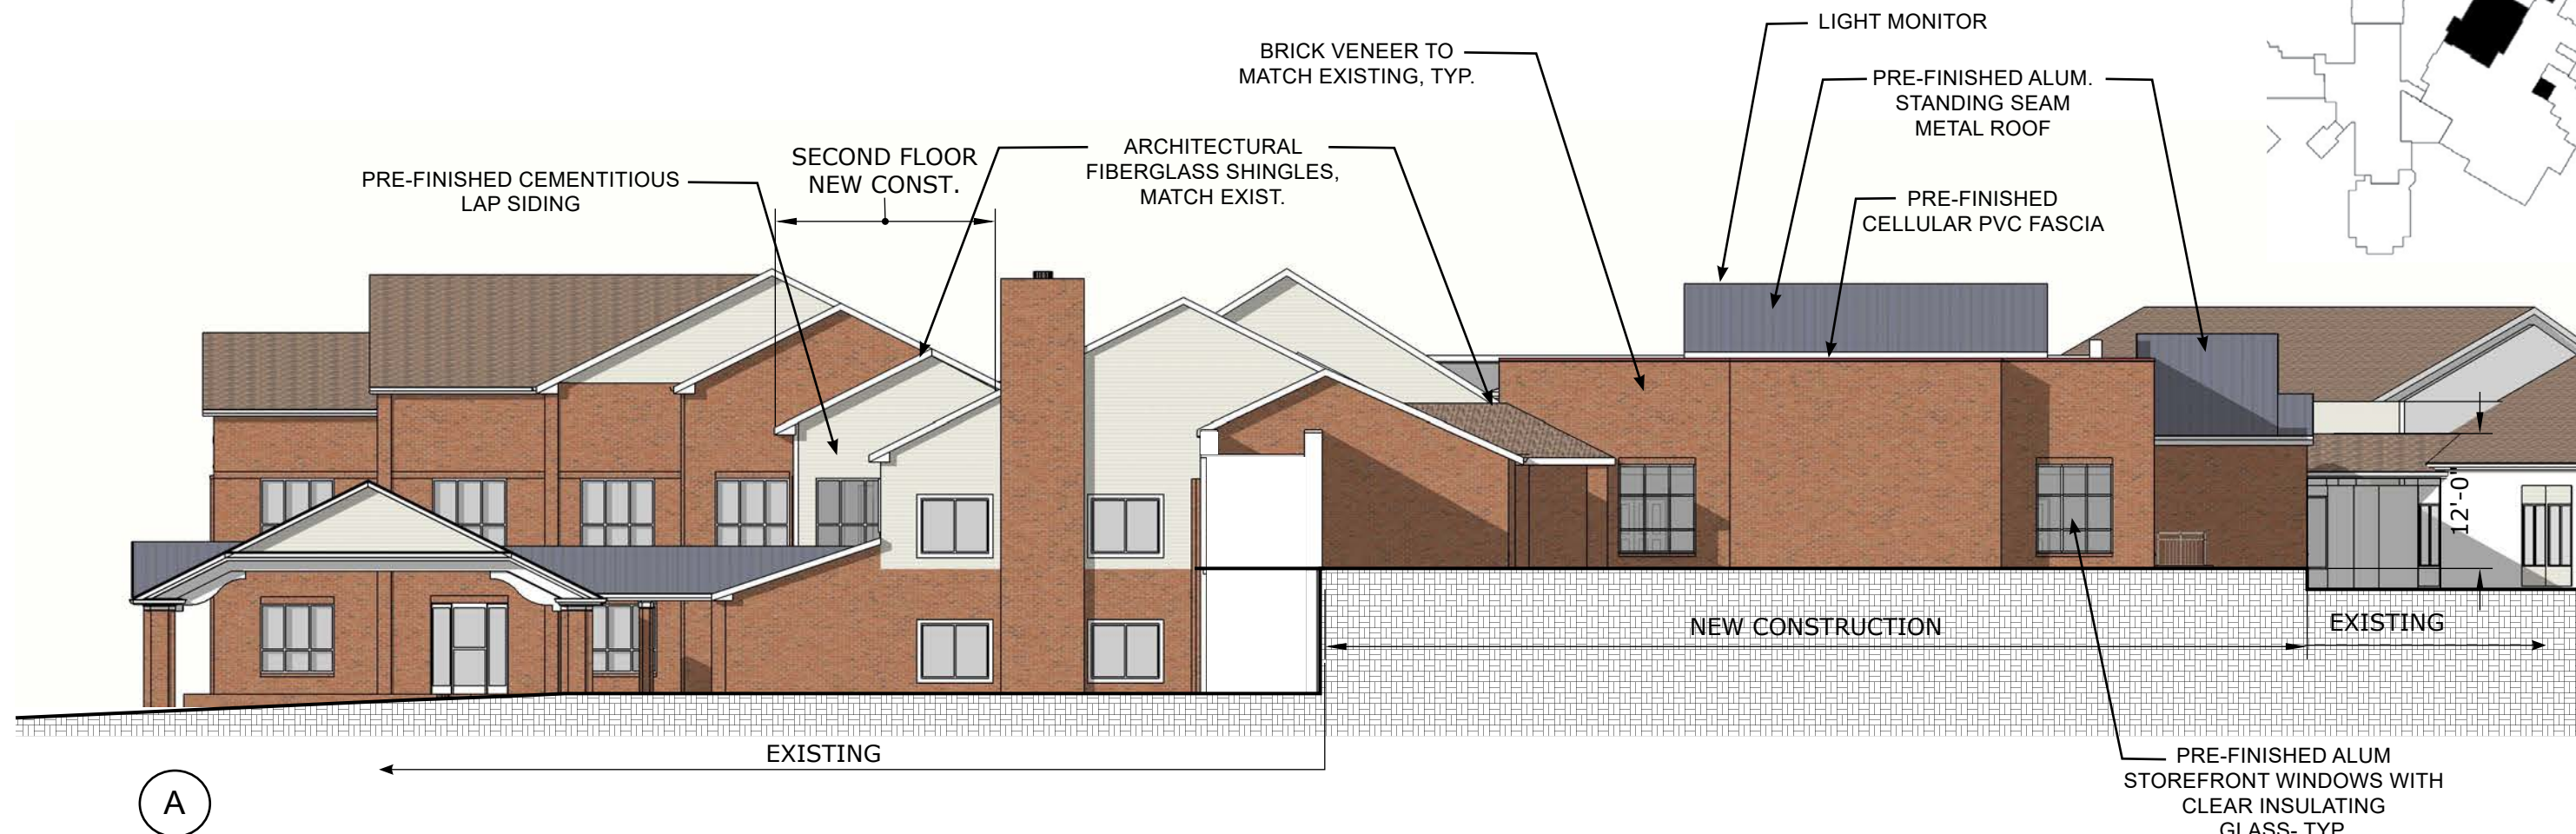
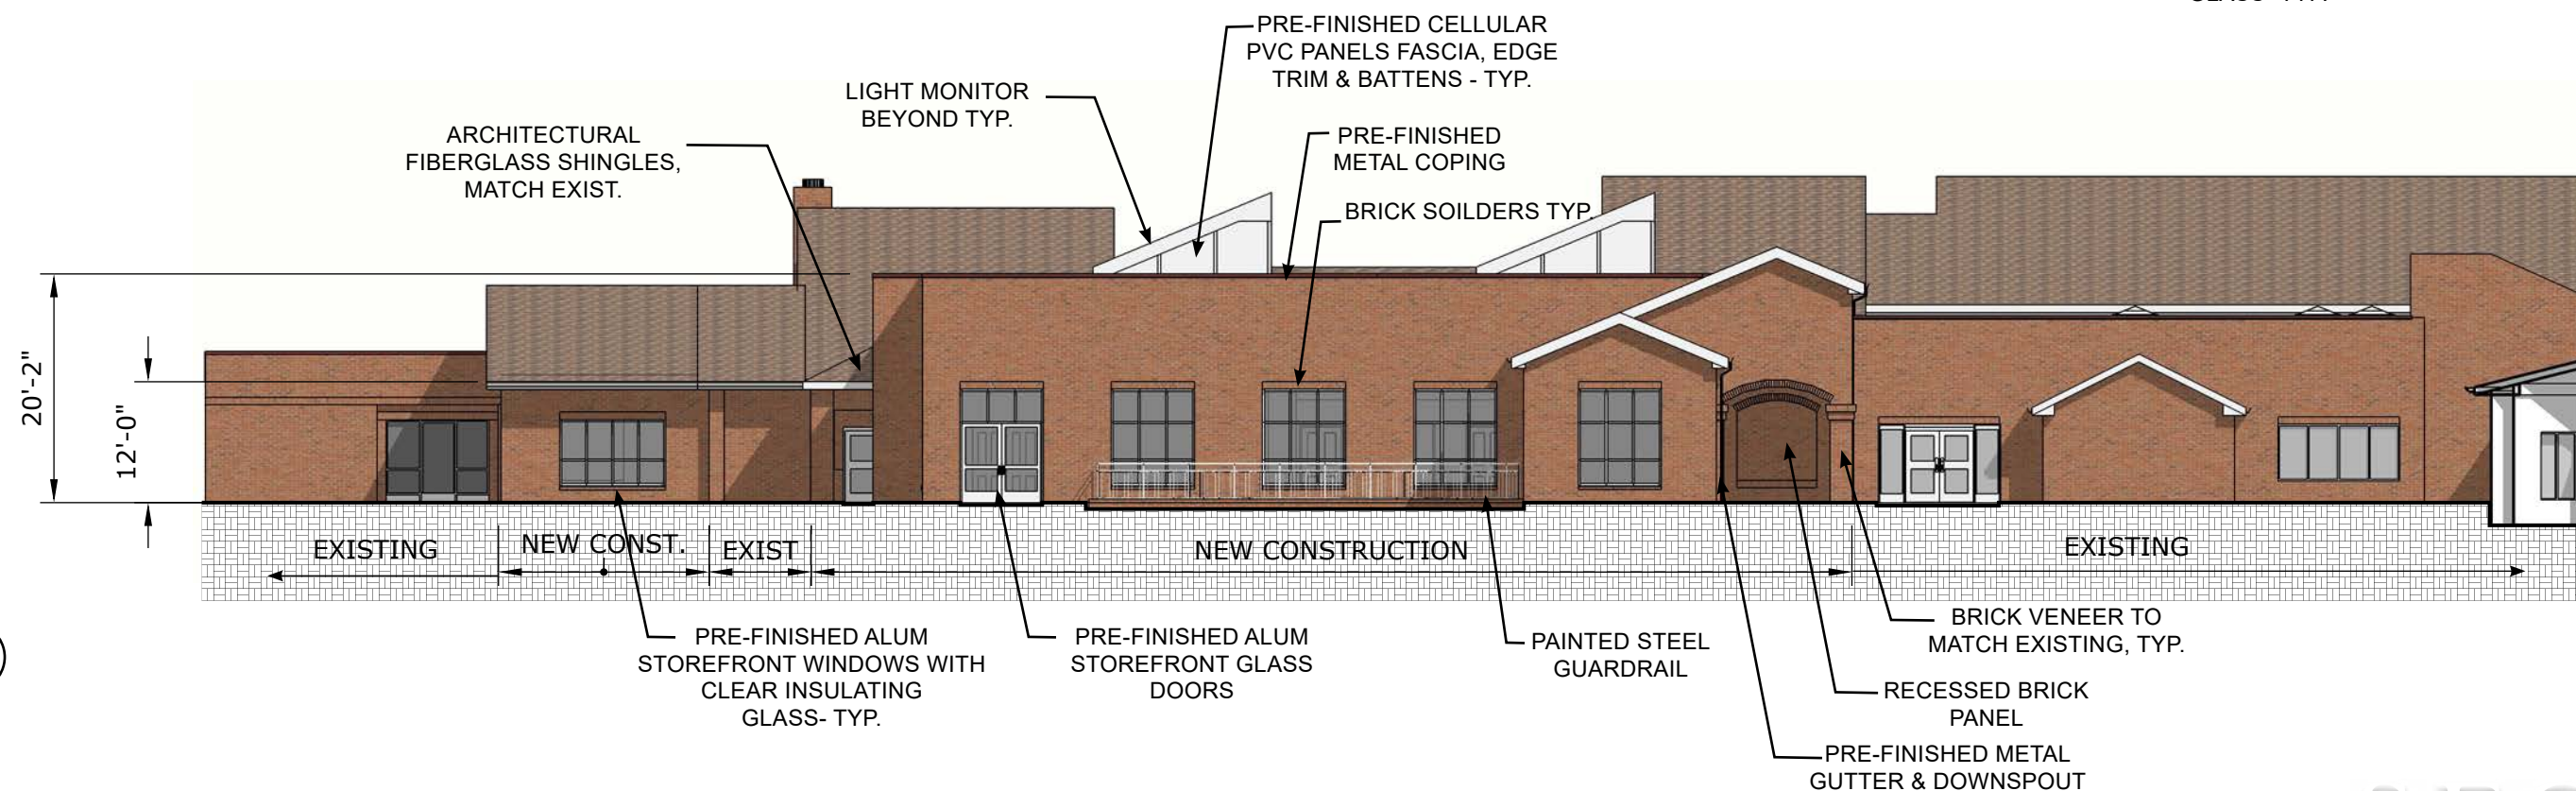
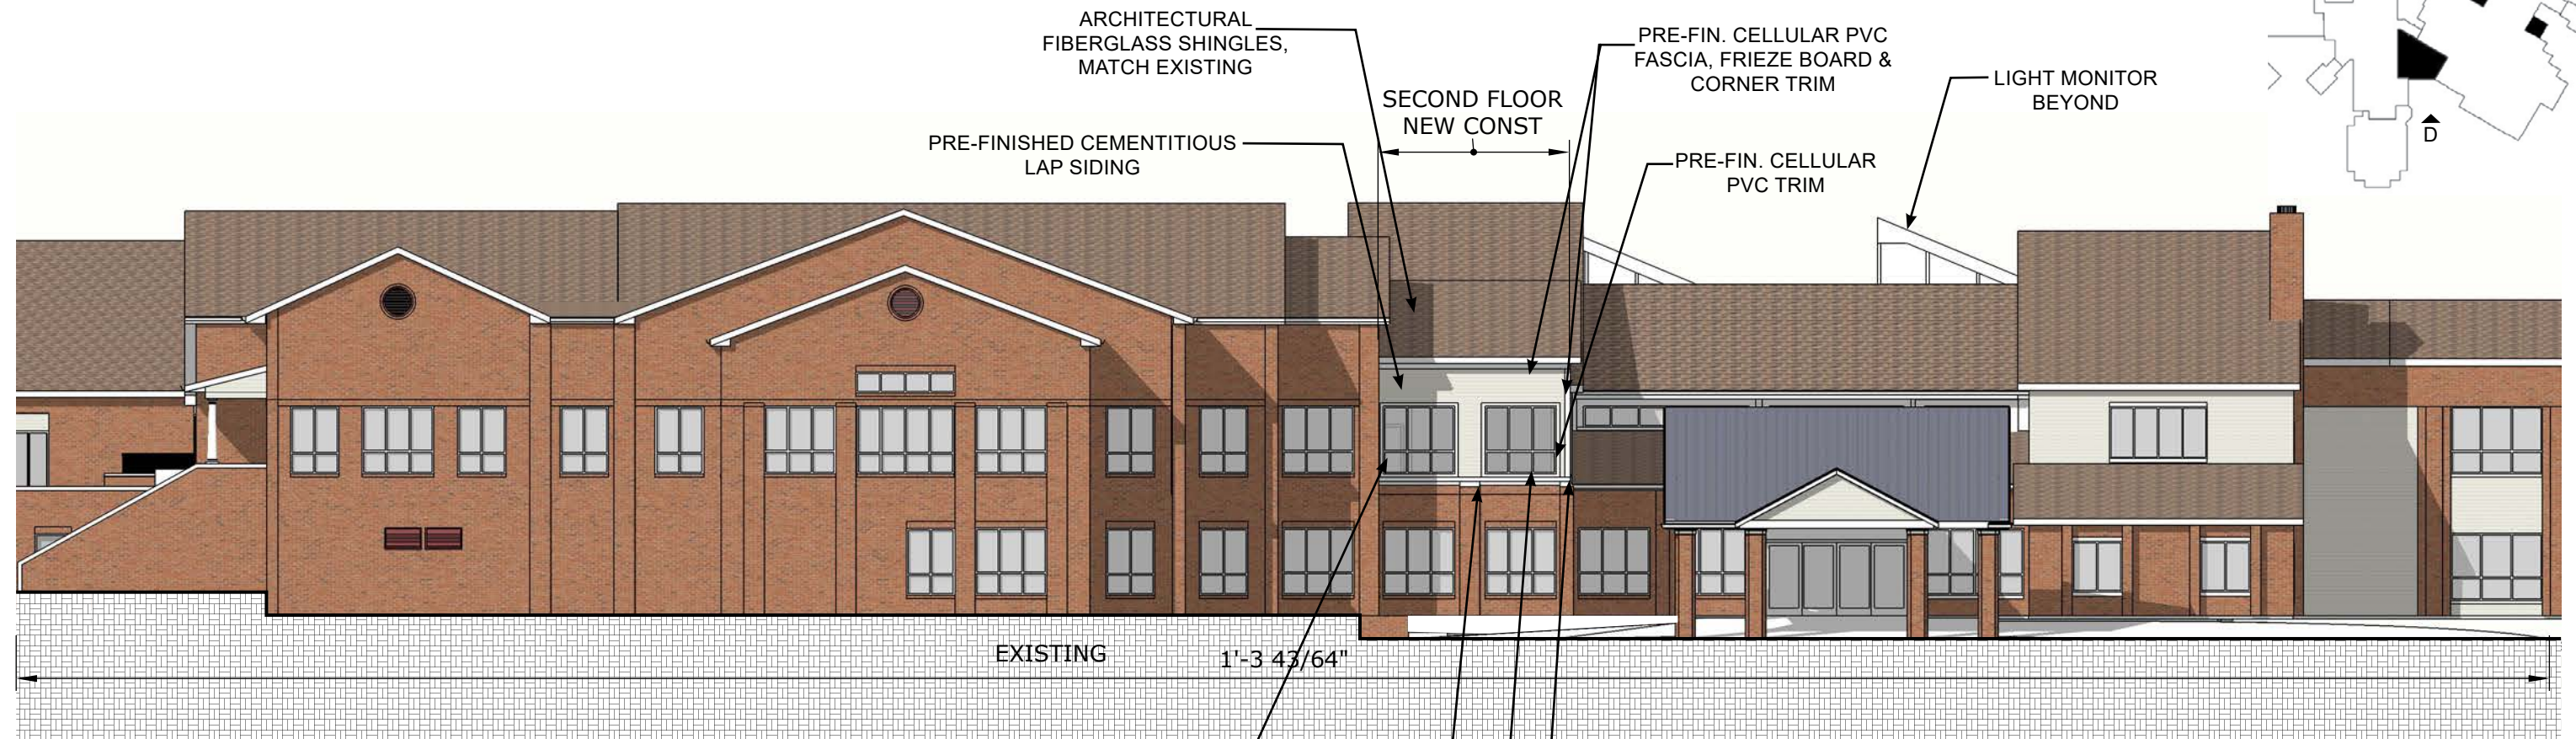
PRE-FINISHED ALUM  
STOREFRONT WINDOWS WITH  
CLEAR INSULATING  
GLASS- TYP.

BRICK VENEER  
MATCH EXISTING  
BOARD & STARTER  
BOARD - TYP.  
CAST STONE  
CAP

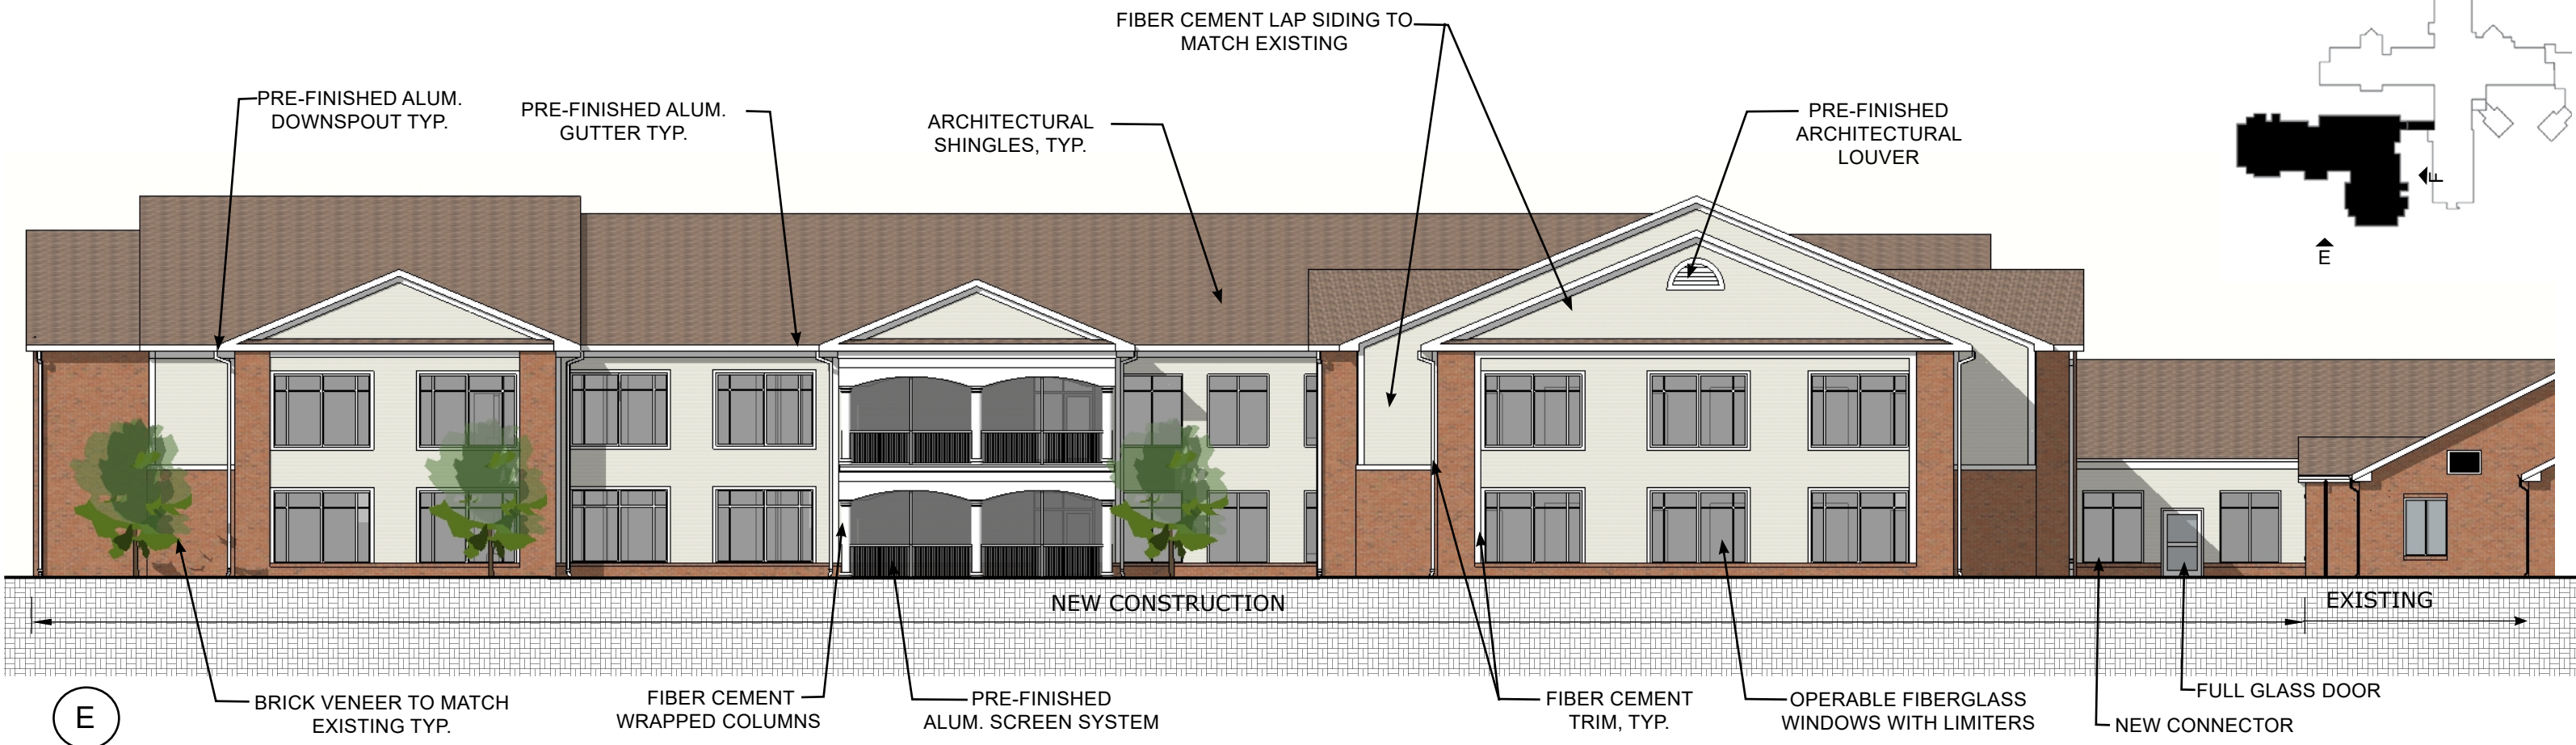
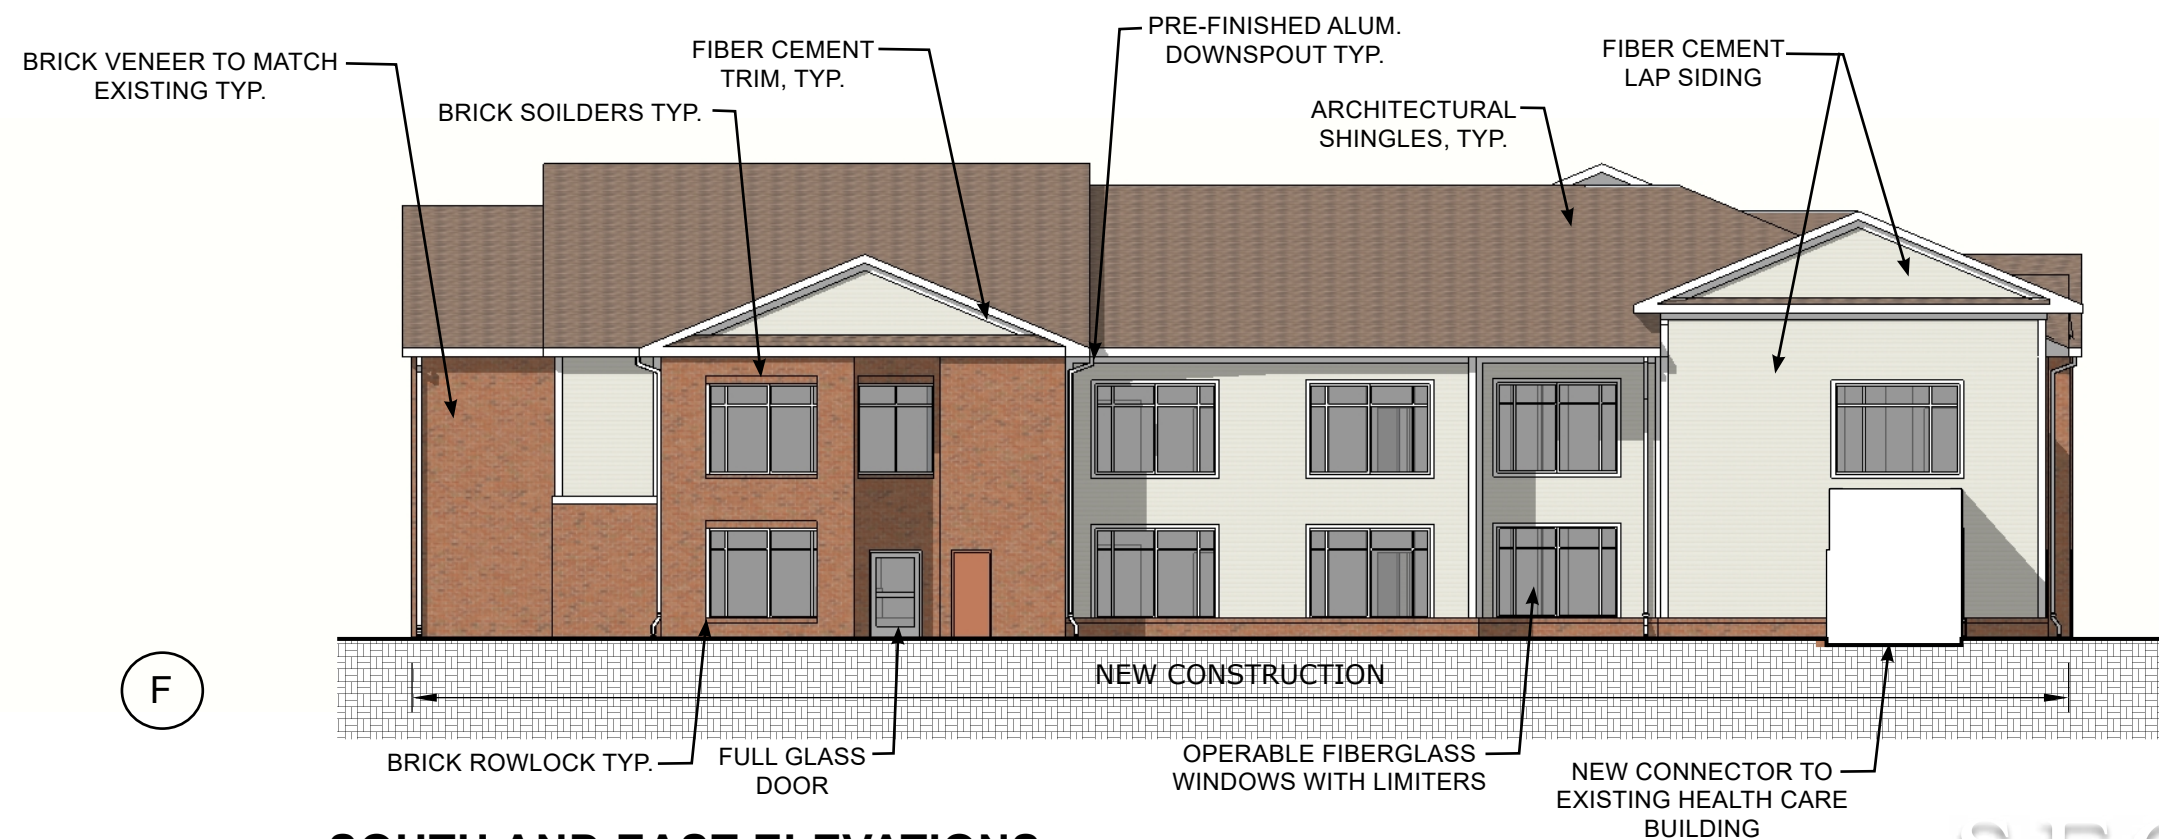
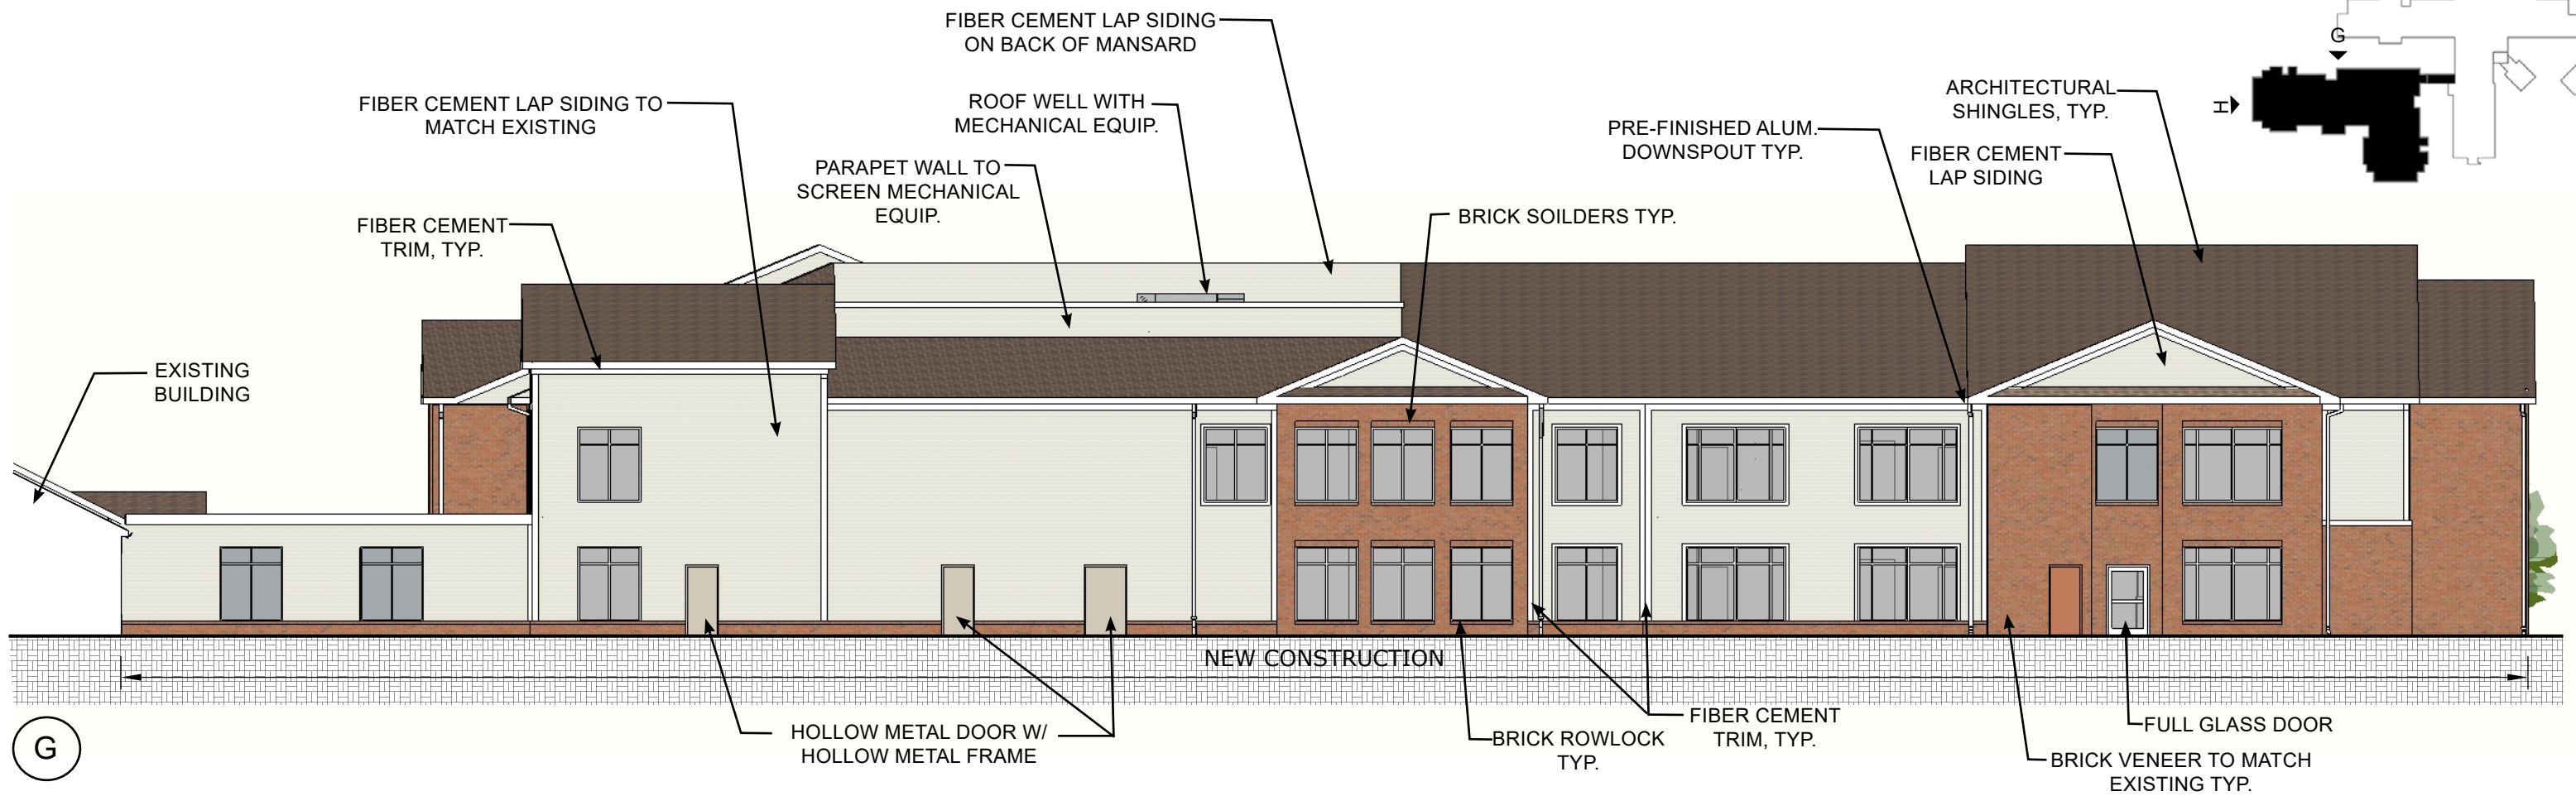
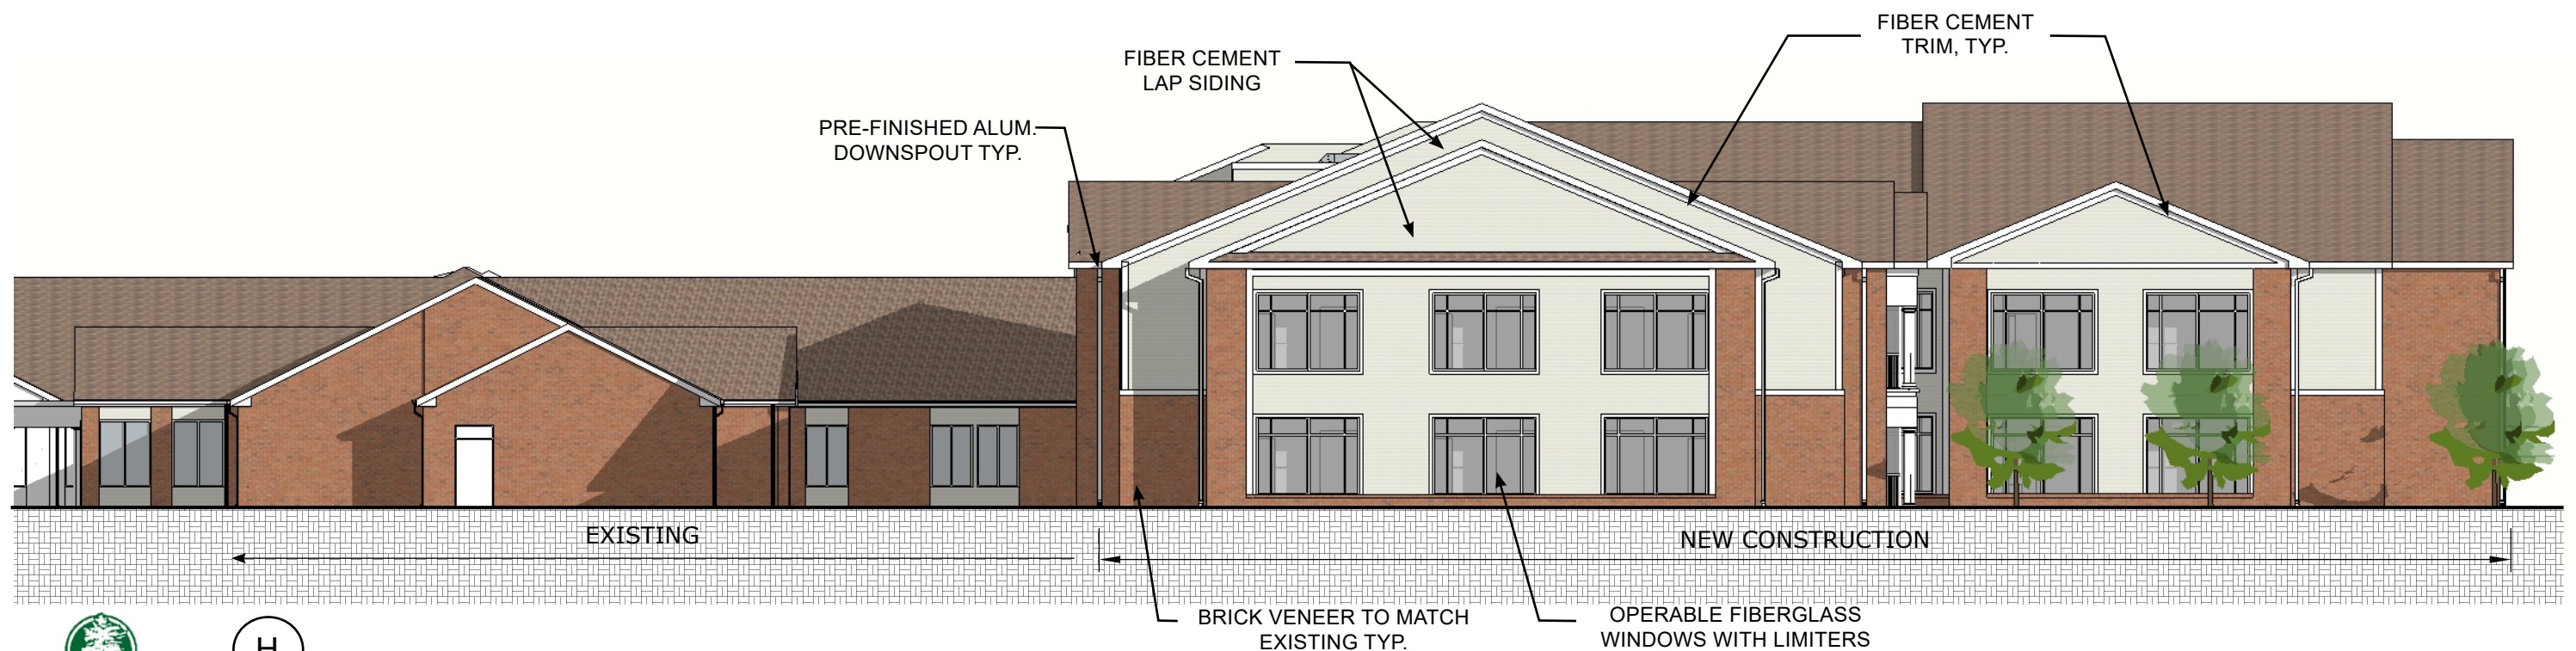
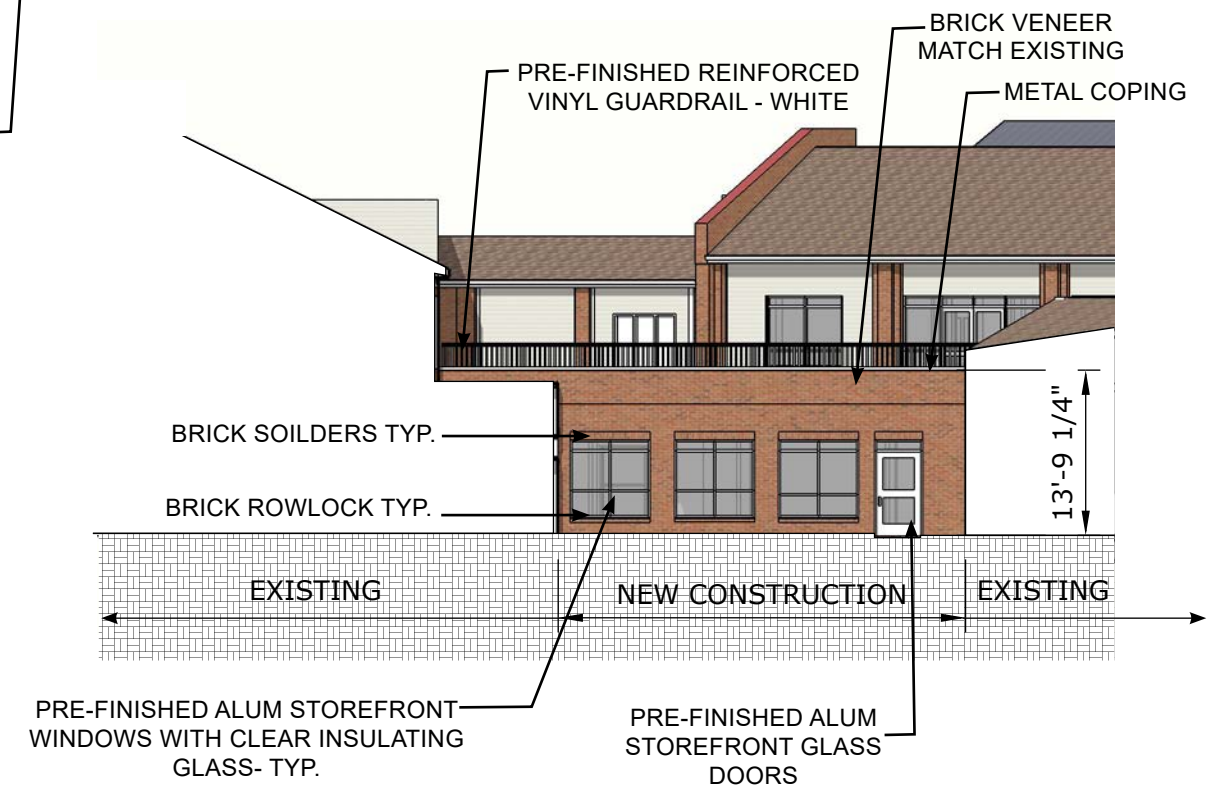
BRICK SOILDERS TYP.

BRICK ROWLOCK TYP.

PRE-FINISHED ALUM STOREFRONT  
WINDOWS WITH CLEAR INSULATING  
GLASS- TYP.

PRE-FINISHED ALUM STOREFRONT  
GLASS  
DOORS
